## Përmbledhje Mujore e Punëve në Landfill

### Landfill – Janar 2026

## Monthly Summary of Landfill Operations

### Landfill – January 2026

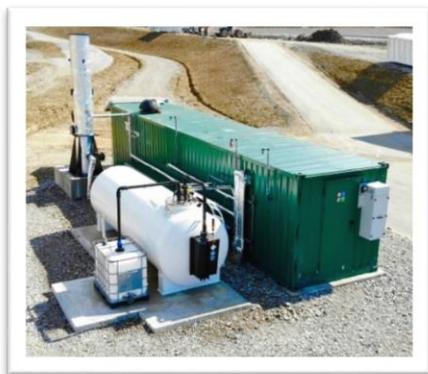
#### 1. Impjanti i Trajtimit të Ujërave – Leachate Treatment Plant

- A total amount of **1860 m<sup>3</sup> of leachate** was recorded, which was treated in the reverse osmosis (RO) plant.
- The treatment process has passed all technical stages of filtration and purification, ensuring the reduction of pollutants and compliance with the parameters required by legal standards.

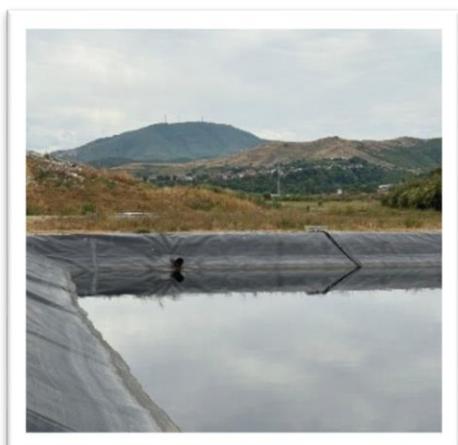
#### 2. Pellgu i ujit të patrajtuar/ndotur, grumbulluar nga mbetjet - Pond of untreated/polluted water, collected from waste

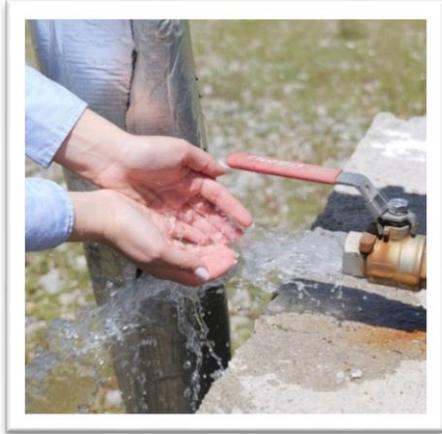
**3. Uji i trajtuar nga Impjanti RO – RO treated water**

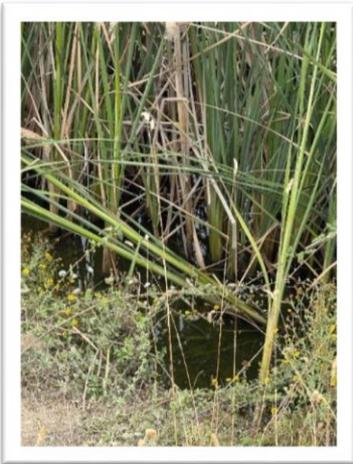
**4. Pellgu i ujit të trajtuar - Treated water pond**

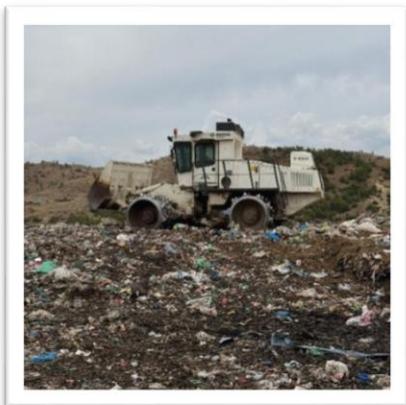
**5. Kompaktori i Mbetjeve – Waste Compactor**

- During January 2026, a total of **3320 tons of waste** were deposited and treated at the landfill.
- The deposit process was carried out according to the daily planning scheme, ensuring regular distribution and compaction.
- The quantities of waste are in line with the monthly average of previous periods and no deviations from the landfill capacities were recorded.

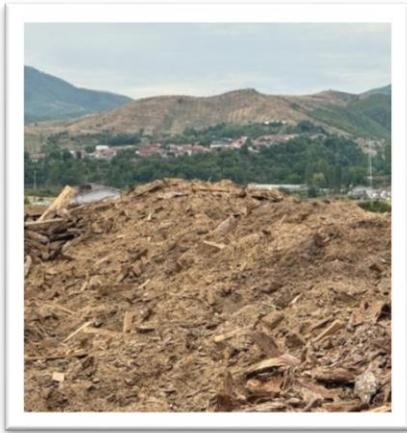
**6.** Materiali mbulues për mbetjet – Waste cover material

- A total of **103 tons of sawdust** were used to cover the waste during the month of January.
- The covering material was distributed in regular layers according to the management plan, helping to:
  - reduce unpleasant odours,
  - prevent the dispersion of waste by wind,
  - limit the presence of insects and rodents,
  - increase the stability and safety of the waste body.

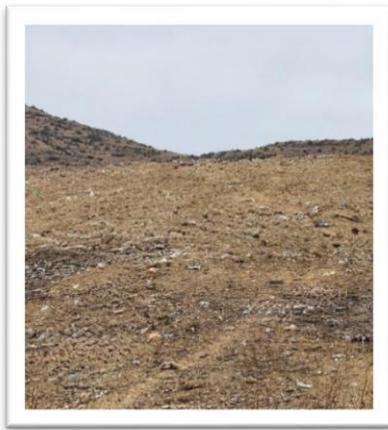
**7.** Mbetjet e mbuluara me *dhe* dhe tallash - Waste covered with soil and sawdust

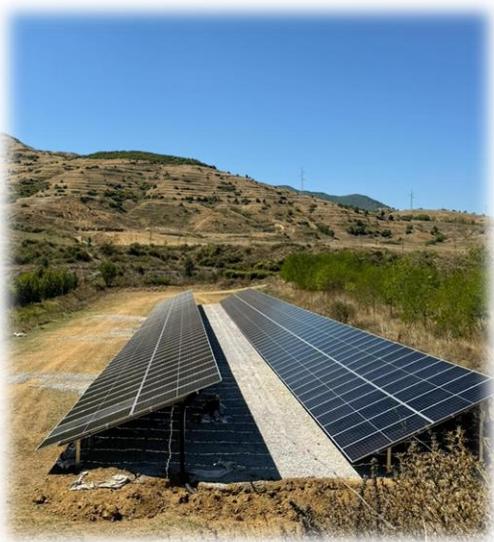
**8.** Panelet Diellore - Solar Panels

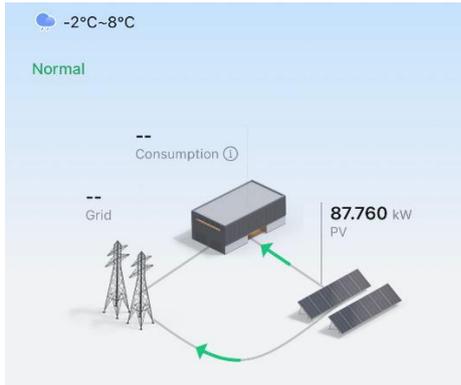
**9. Panelet Diellore - Në kohë reale - 31 Janar - Ora 9:45 / Solar Panels - Live - 31 January**

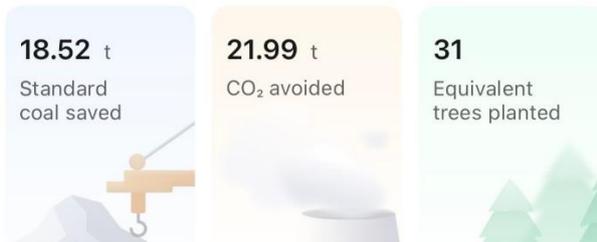
**10. Panelet Diellore - Përfitimet Mjedisore shtator 2025-janar 2026 / Solar Panels – Environmental Benefits September 2025-January 2026**

<b>Environmental Benefits from September 2025 (the installation) until now</b>	<b>No.</b>	<b>Unit of measurement</b>
Standard coal saved	<b>18.52</b>	tons
CO <sub>2</sub> avoided	<b>21.99</b>	tons
Equivalent trees planted	<b>31</b>	pcs

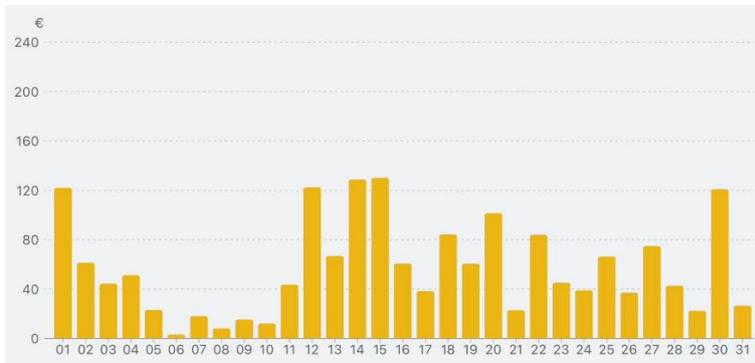
**11. Panelet Diellore - Të ardhurat totale - Janar / Solar Panels - Total Revenues - January**

**Reduction of operating costs:** In January, **1780 Euros** were saved from the use of panels.

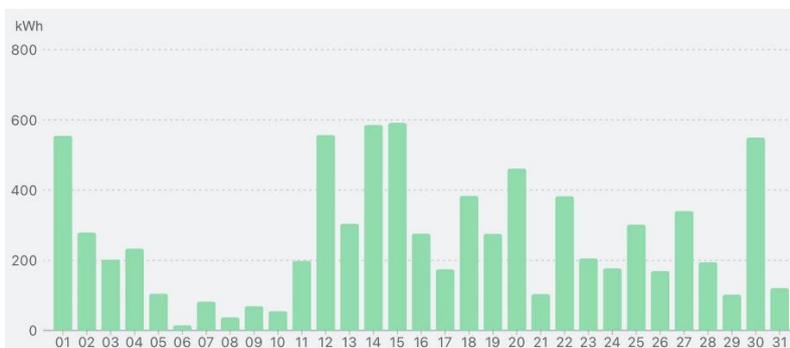
**12. Panelet Diellore - Energjia e prodhuar - Janar / Solar Panels - Energy produced - January**

**Environmental sustainability:** During the month of January, **8.08 MWh** (Megawatt per hour) were produced.
